RADC-TR-79-167
Final Technical Report
October 1979

# CMOS LIFE SUITABILITY EVALUATION PROGRAM

McDonnell Douglas Astronautics Company

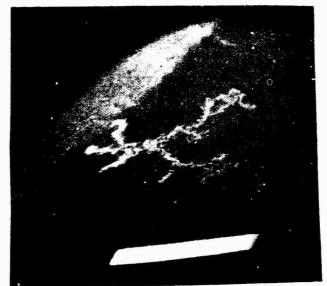
FIGURE D7 - CROSS-SECTION OF THE PACKAGE SHOWING DARK STAIN AROUND THE LEADS. THIS PART CONTAINED A SHORT BETWEEN PINS 4 AND 5 AND HAS A BRIDGING STAIN (ARROW) BETWEEN PINS 4 AND 5.

S/N A135 (4000 HRS/225°C) FIGURE D8 - SEM PHOTO OF THE STAIN.

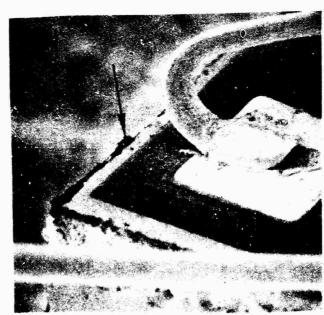
250X (SEM-1.3 K.V.) S/N A225 (4 HRS/250°C)

FIGURE D9 - EXAMPLE OF SILICON LASER SCRIBE
HILLOCK (ARROW) AT THE FAILURE
SITE EXPOSED BY LIFTING THE
ALUMINUM WIRE.

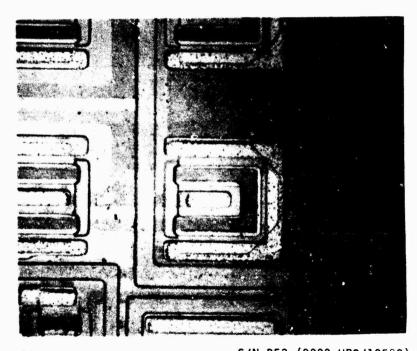
S/N B53 (2000 HRS/125°C)
FIGURE D17 - EXAMPLE OF A DEGRADED N-CHANNEL "ON"
TRANSISTOR (N4 OF GATE B) AFTER METAL REMOVAL.

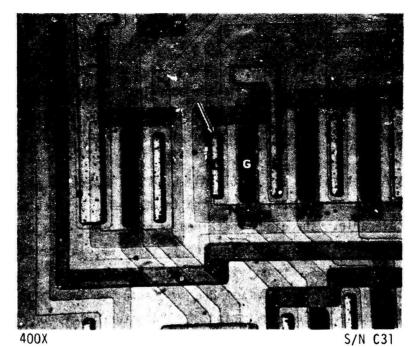
The misregistration problem would likely be lot dependent but strangely no Lot C part failed due to this problem during the Lot C acceptance test even though this test was performed at 250°C. Five parts that survived the Lot C life test were delidded and examined. All five contained misregistered ohmic contacts. The worst case example is shown in Figure D39. This suggests that the mechanism that caused the contact to progress to failure may not have been time-temperature dependent, but rather was induced by random stress such as an electrical transient.

FIGURE D39 - F/F1 N15 OF A LOT ACCEPTANCE TEST SURVIVOR SHOWING THE DRAIN CONTACT (ARROW) OVERLAPPING THE JUNCTION.

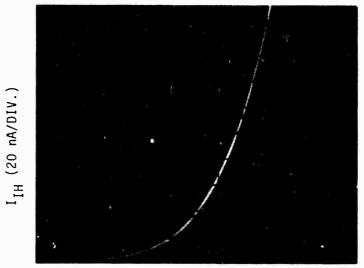
FIGURE D55 - EXAMPLE OF PIN 13 I<sub>IH</sub> I-V CHARACTERISTIC.
